# **CERTIFIED INDEPENDENT RV INVESTIGATION REPORT OF ALLEGED MANUFACTURER DEFECTS**

**INDIV-291-1218-RV-WARRANTY-INSPEC-WOOD**

On January 3, 2019 and January 16, 2019 conducted an independent investigation of a 2016 Winnebago Class A Grand Tour motor coach at 5455 S. Valley Blvd., Las Vegas, Nevada. I was asked to investigate the RV relative to current alleged product defects, any undiscovered product defects and to render an opinion on the past work orders in the form of a "Vehicle Problem Analysis".

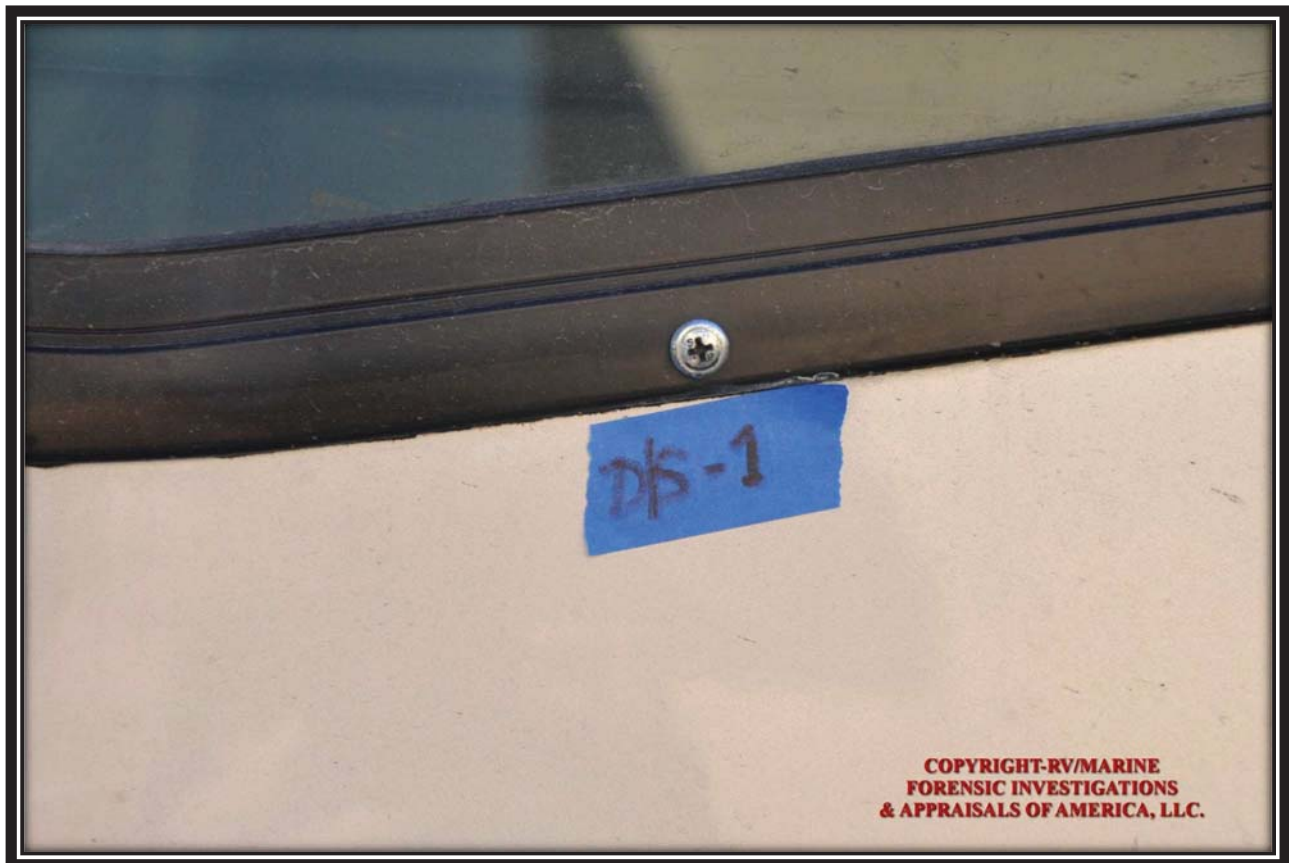
4. *Excess caulking around window.* Conclusion: The window caulking was not trimmed off. Allegation Confirmed. As such it would not have been merchantable, i.e., it would not pass without objection in the trade. Refer to Fig. 4

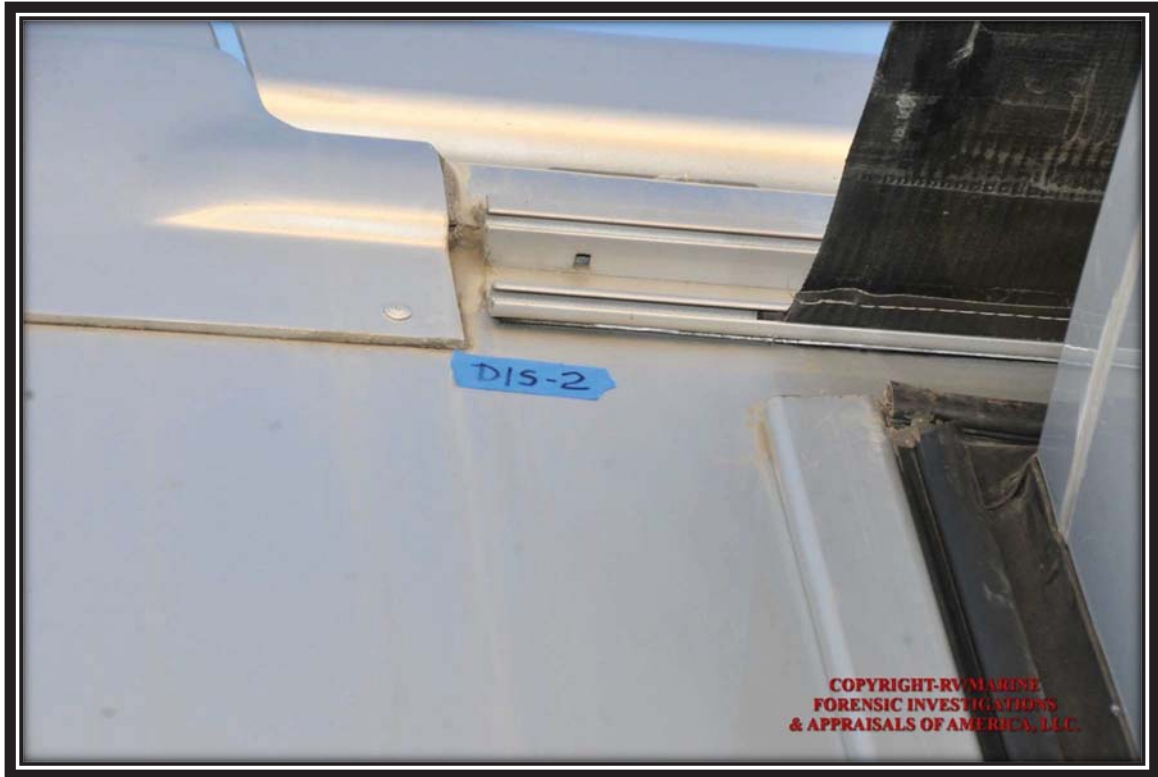
Fig. 5

5. *D/S awning rail not trimmed.* Conclusion: The awning rail had excessive length. Allegation Confirmed. As such it would not have been merchantable, i.e., it would not pass without objection in the trade. Refer to Fig. 5.

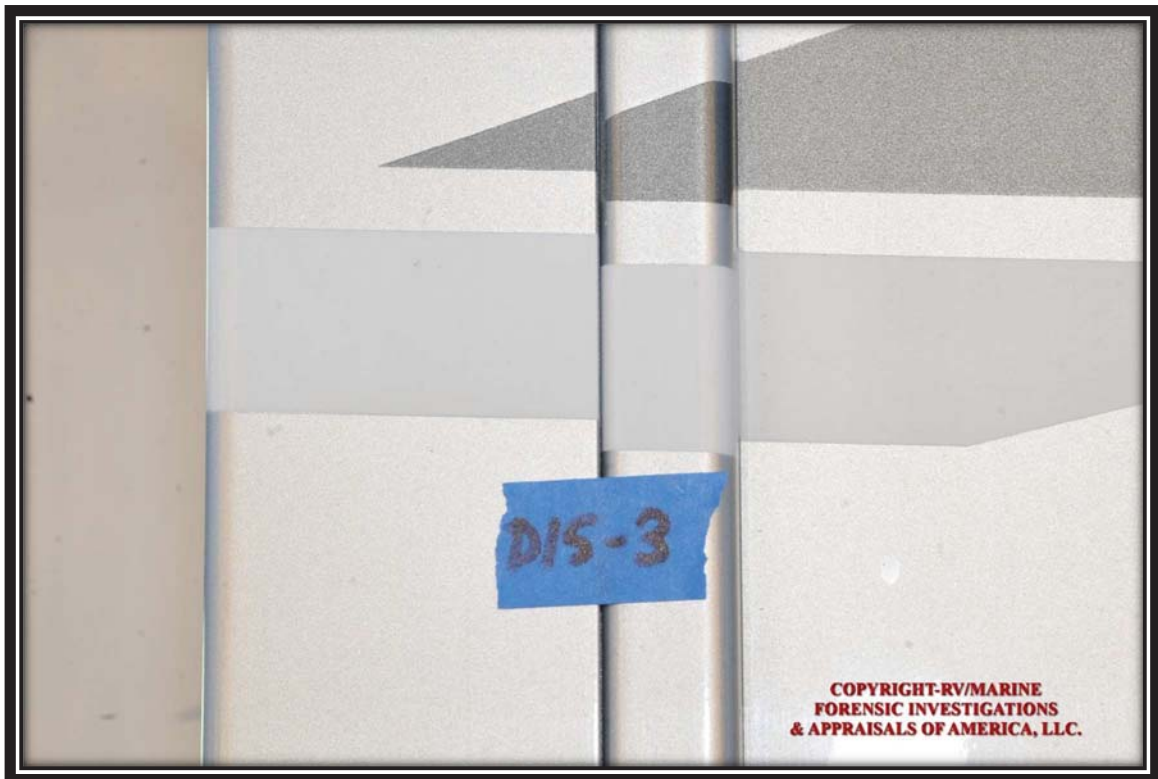
Fig. 6

6. *Paint striping does not match.* Conclusion: The paint stripes are not aligned. Allegation Confirmed. As such it would not have been merchantable, i.e., it would not pass without objection in the trade. Refer to Fig. 6.

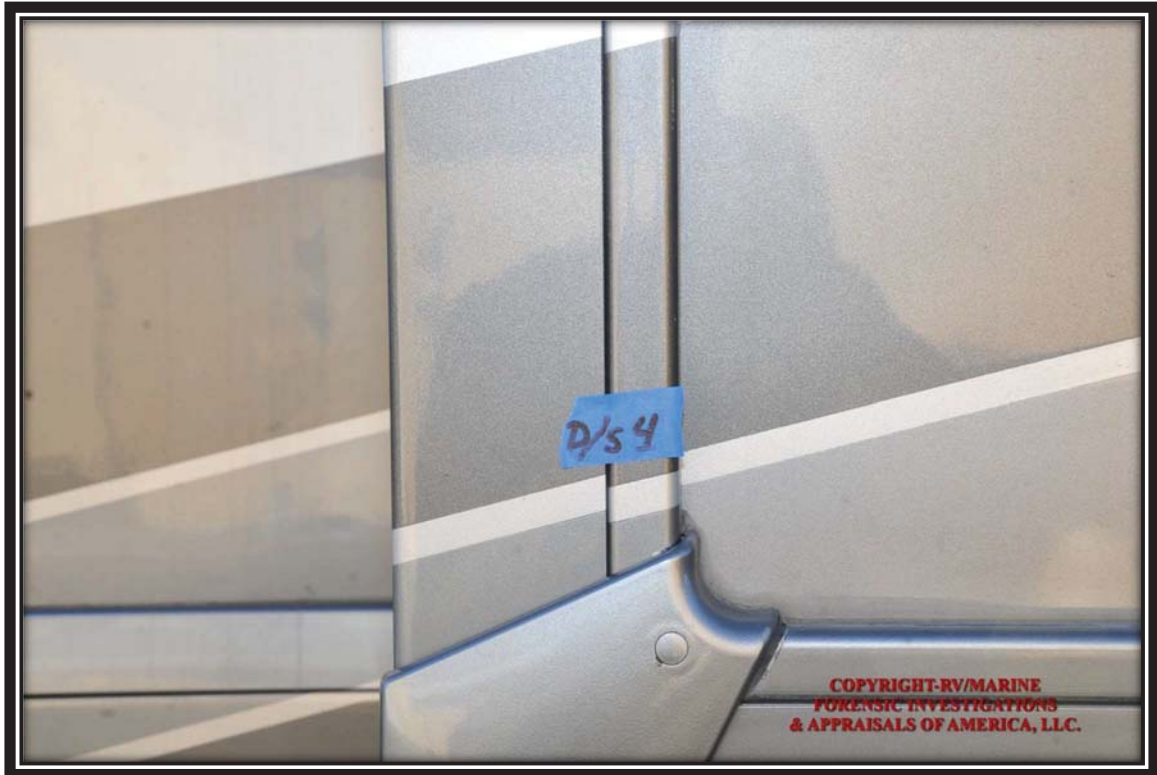
Fig. 7

7. *Paint striping does not match.* Conclusion: The paint stripes are not aligned. Allegation Confirmed. As such it would not have been merchantable, i.e., it would not pass without objection in the trade. Refer to Fig. 7.

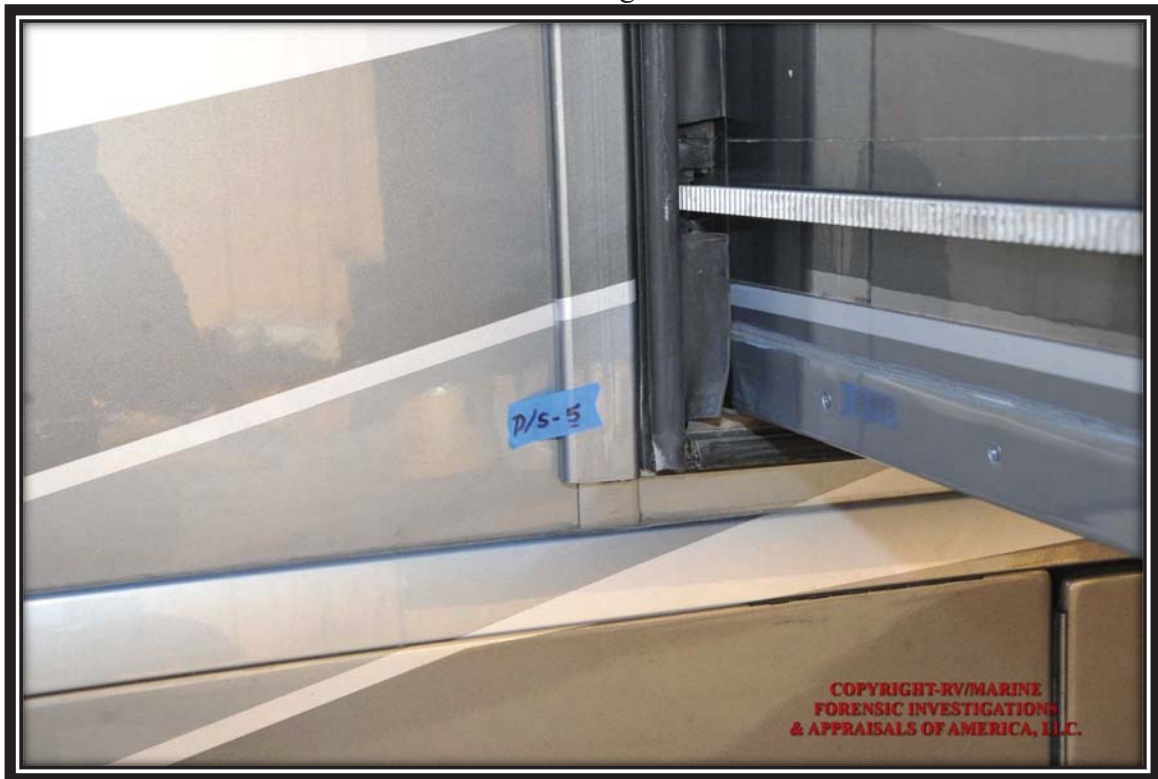
Fig. 8

8. *Paint striping does not match.* Conclusion: The paint stripes are not aligned. Allegation Confirmed. As such it would not have been merchantable, i.e., it would not pass without objection in the trade. Refer to Fig. 8.

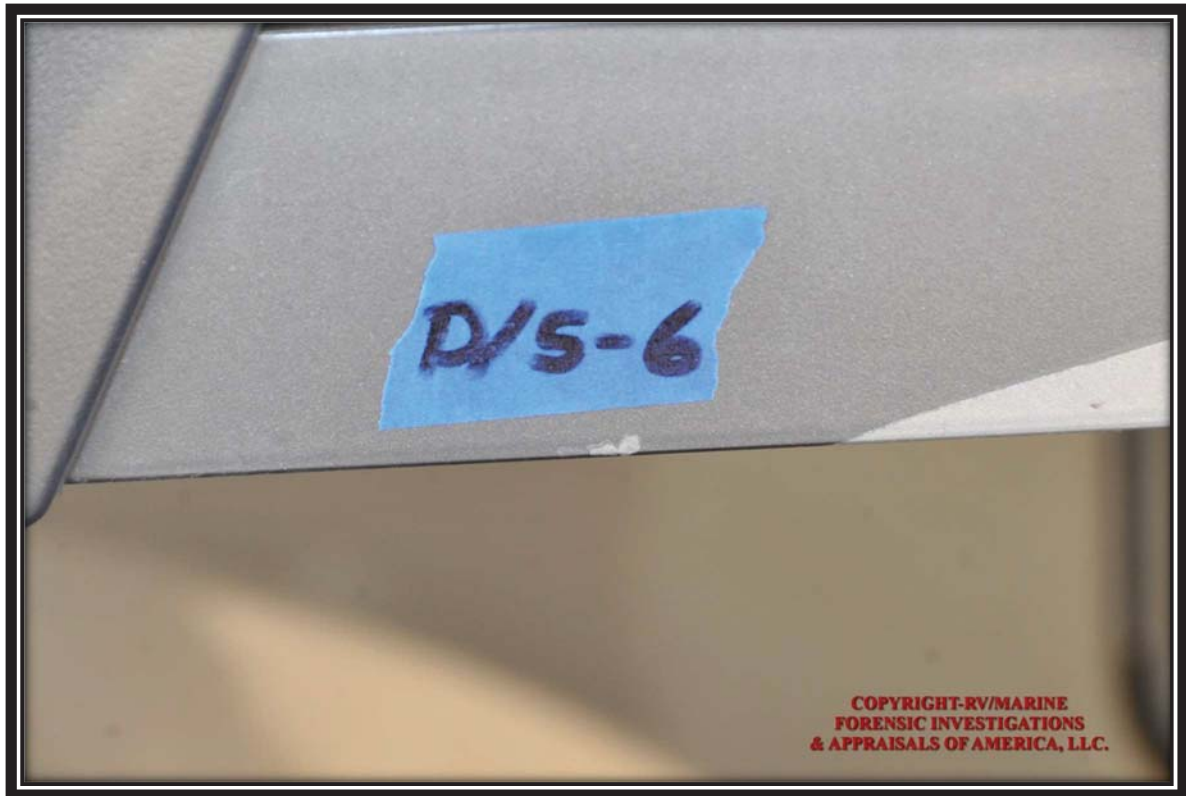
Fig. 9

9. *Paint flaw.* Conclusion: The paint surface was not properly prepared. Allegation Confirmed. As such it would not have been merchantable, i.e., it would not pass

without objection in the trade. Refer to Fig. 9.

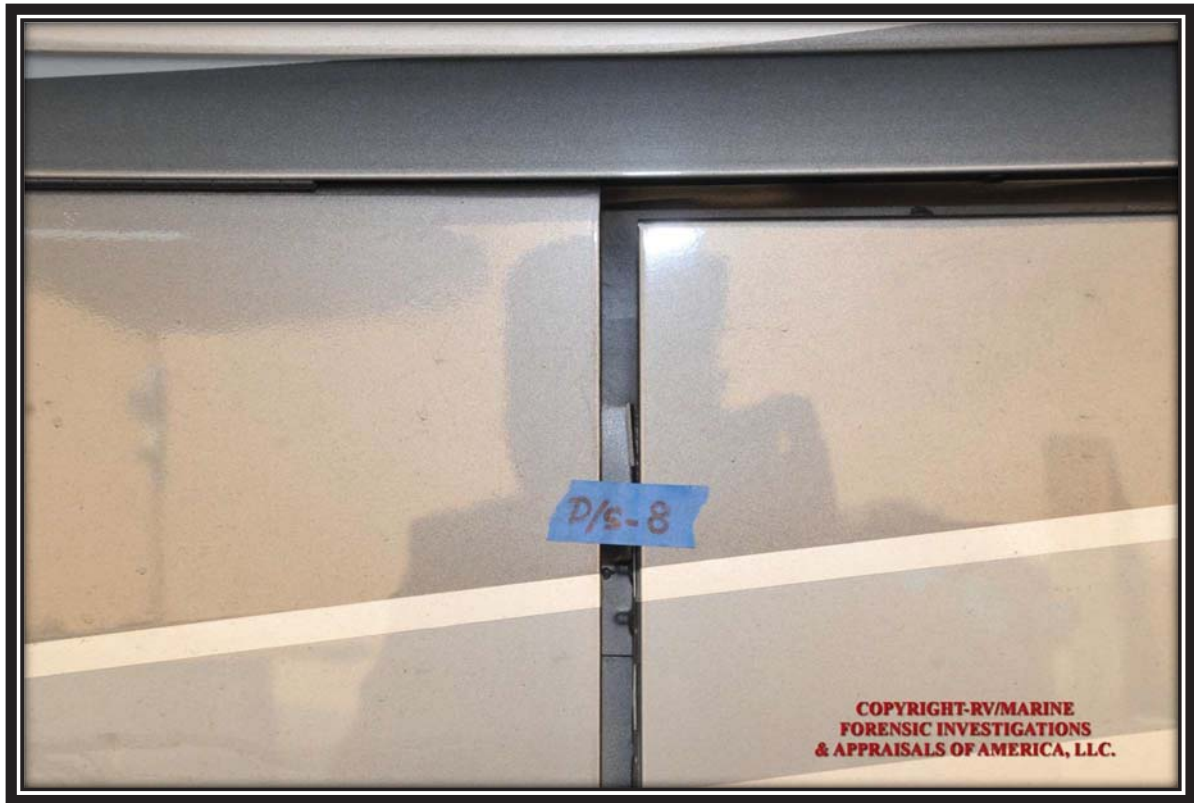
Fig. 11

11. *The compartment door is not properly aligned.* Conclusion: The door is not aligned straight. Allegation Confirmed. As such it would not have been merchantable, i.e., it would not pass without objection in the trade. Refer to Fig. 11.

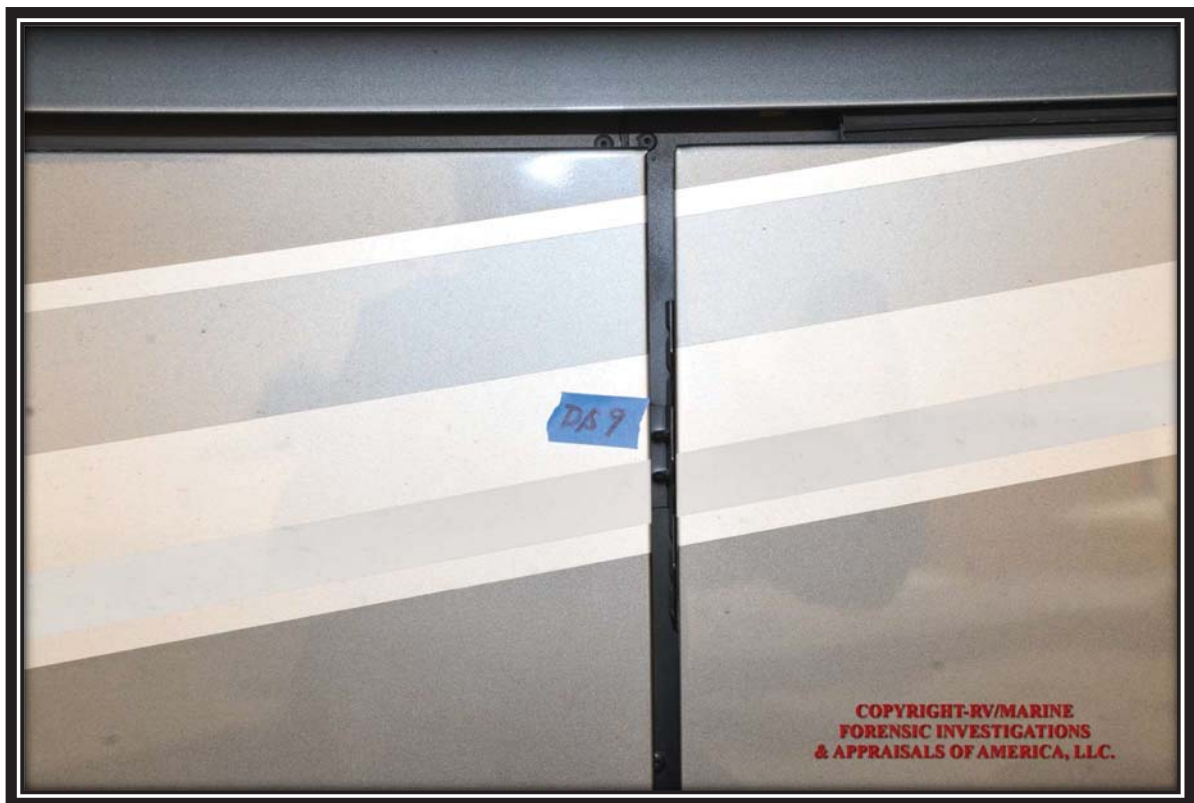
Fig. 12

12. *The compartment door is not properly aligned.* Conclusion: The door is not aligned. Allegation Confirmed. As such it would not have been merchantable, i.e., it would not pass without objection in the trade. Refer to Fig. 12.

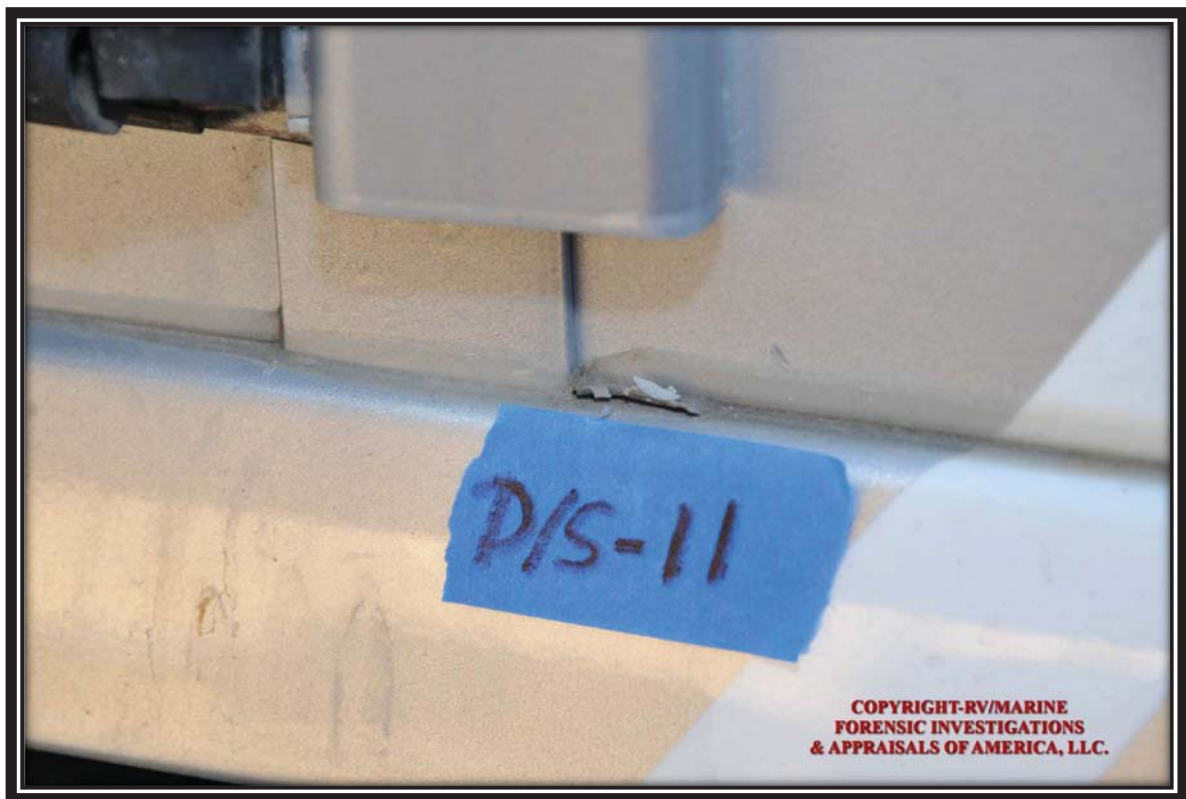
Fig. 14

14. *Cracked sealant.* Conclusion: The sealant was not applied properly. Allegation Confirmed. As such it would not have been merchantable, i.e., it would not pass without objection in the trade. Refer to Fig. 14.

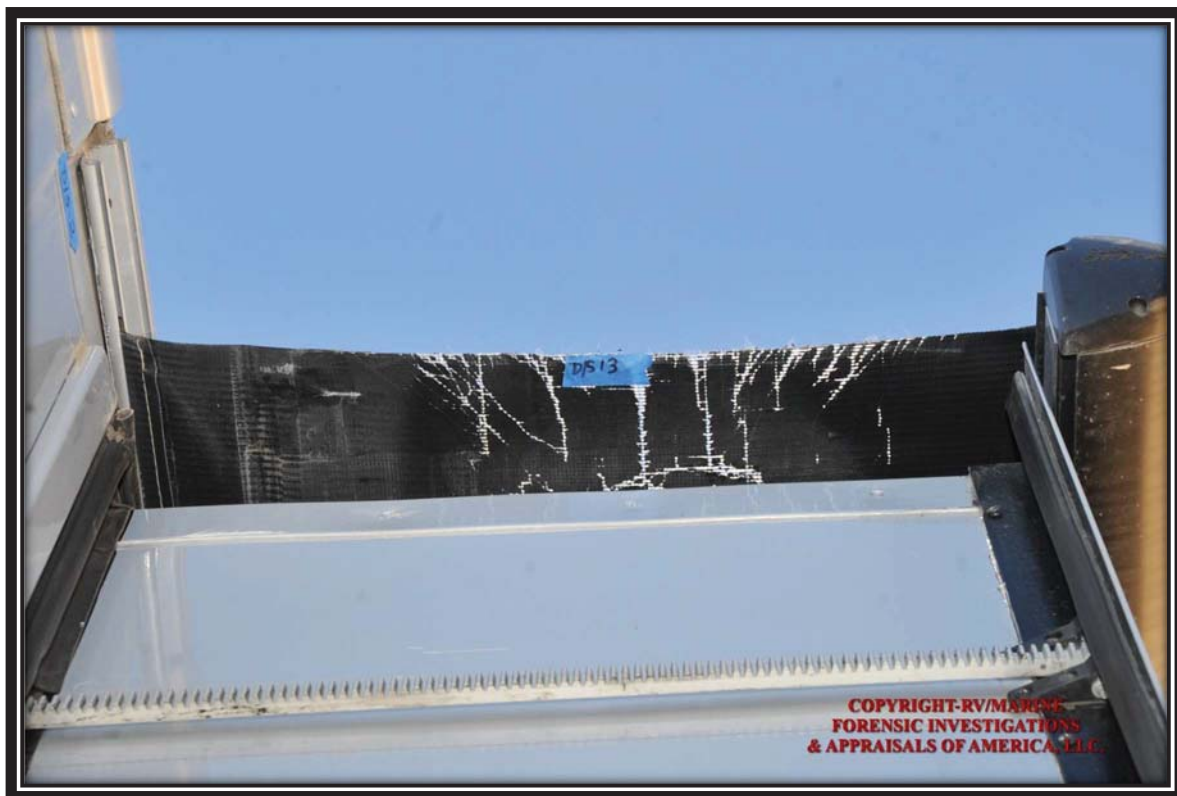
Fig. 16

16. *Awning fabric deteriorated.* Conclusion: The fabric material failed. Allegation Confirmed. As such it would not have been merchantable, i.e., it would not pass without objection in the trade. Refer to Fig. 16.

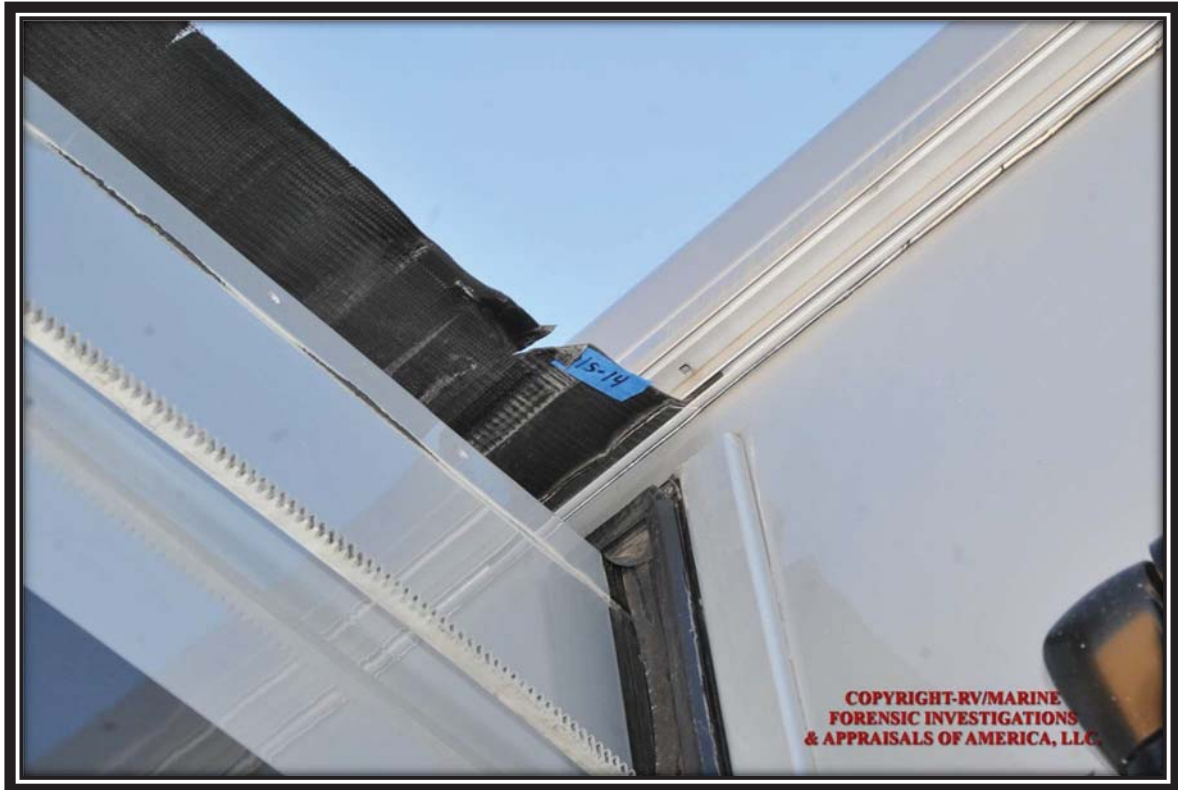
Fig. 17

17. *Awning fabric tore.* Conclusion: The fabric failed and tore. Allegation Confirmed. As such it would not have been merchantable, i.e., it would not pass without objection in the trade. Refer to Fig. 17.

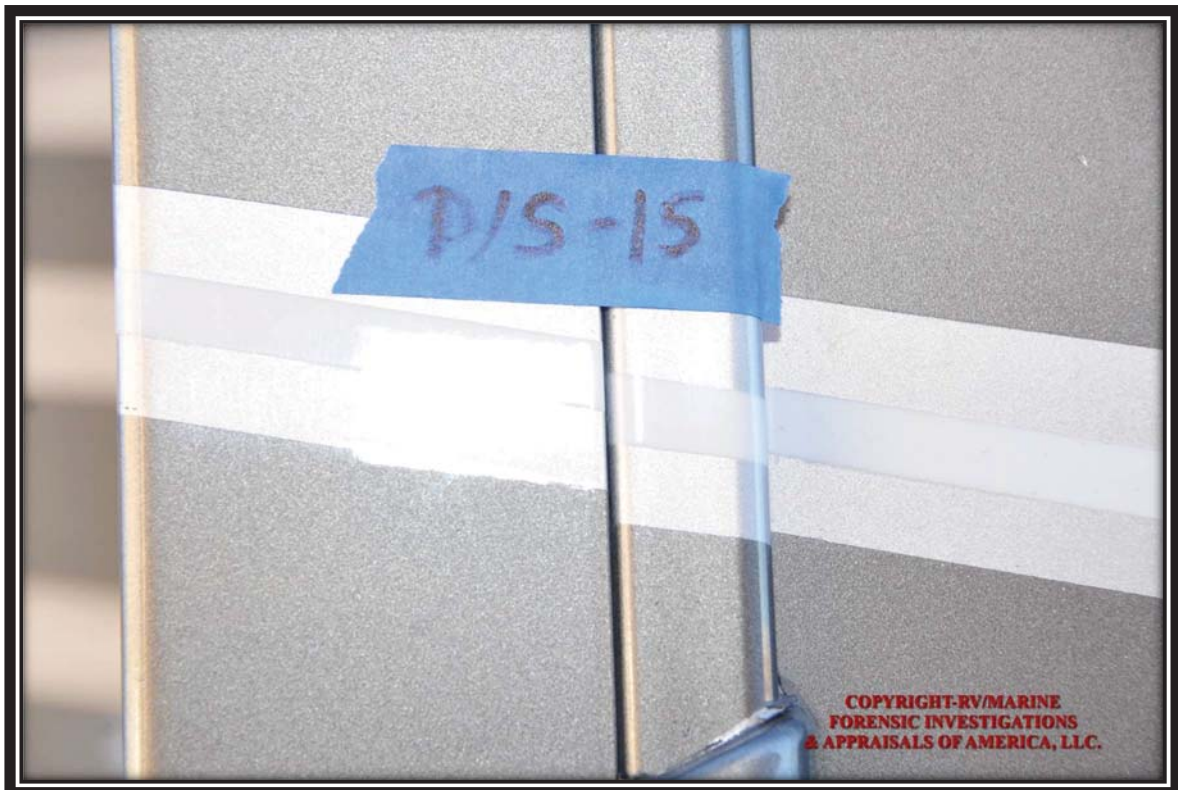
Fig. 18

18. *Paint striping does not match.* Conclusion: The paint stripes are not aligned. Allegation Confirmed. As such it would not have been merchantable, i.e., it would not pass without objection in the trade. Refer to Fig. 18.

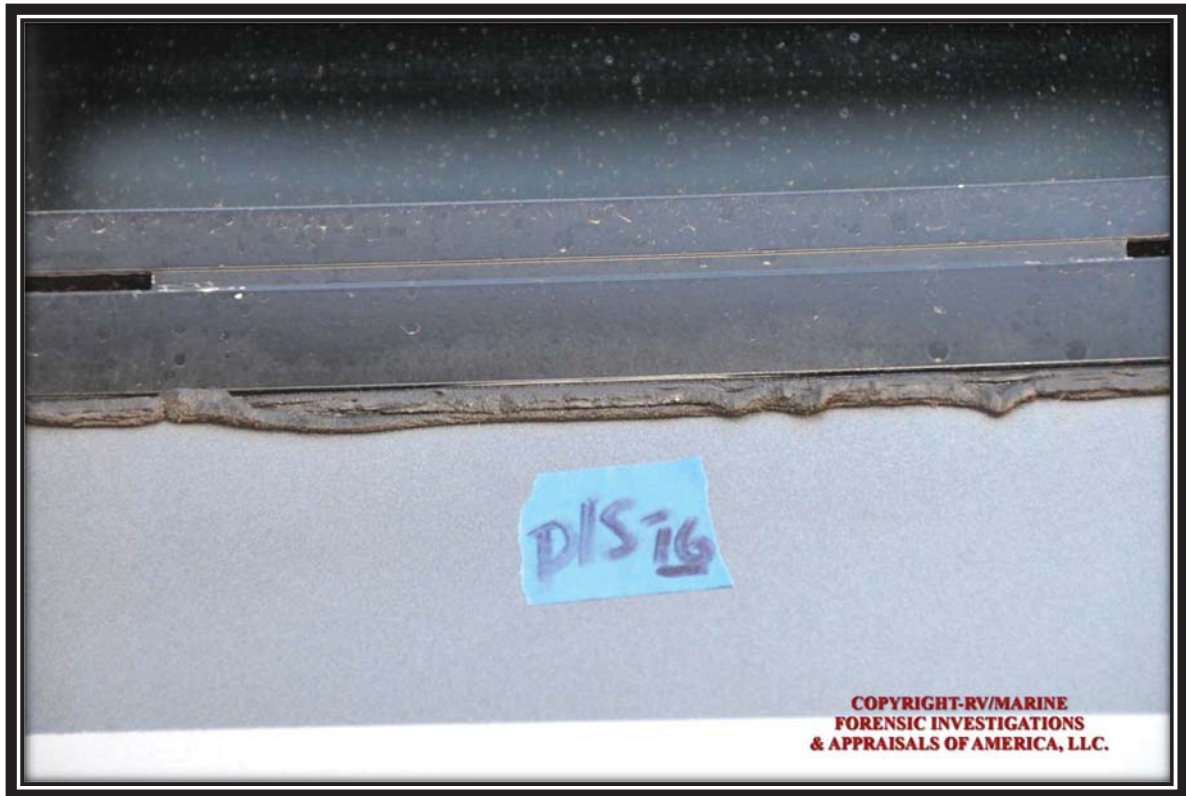
19. *Excess caulking around window.* Conclusion: The window caulking was not trimmed off. Allegation Confirmed. As such it would not have been merchantable, i.e., it would not pass without objection in the trade. Refer to Fig. 19

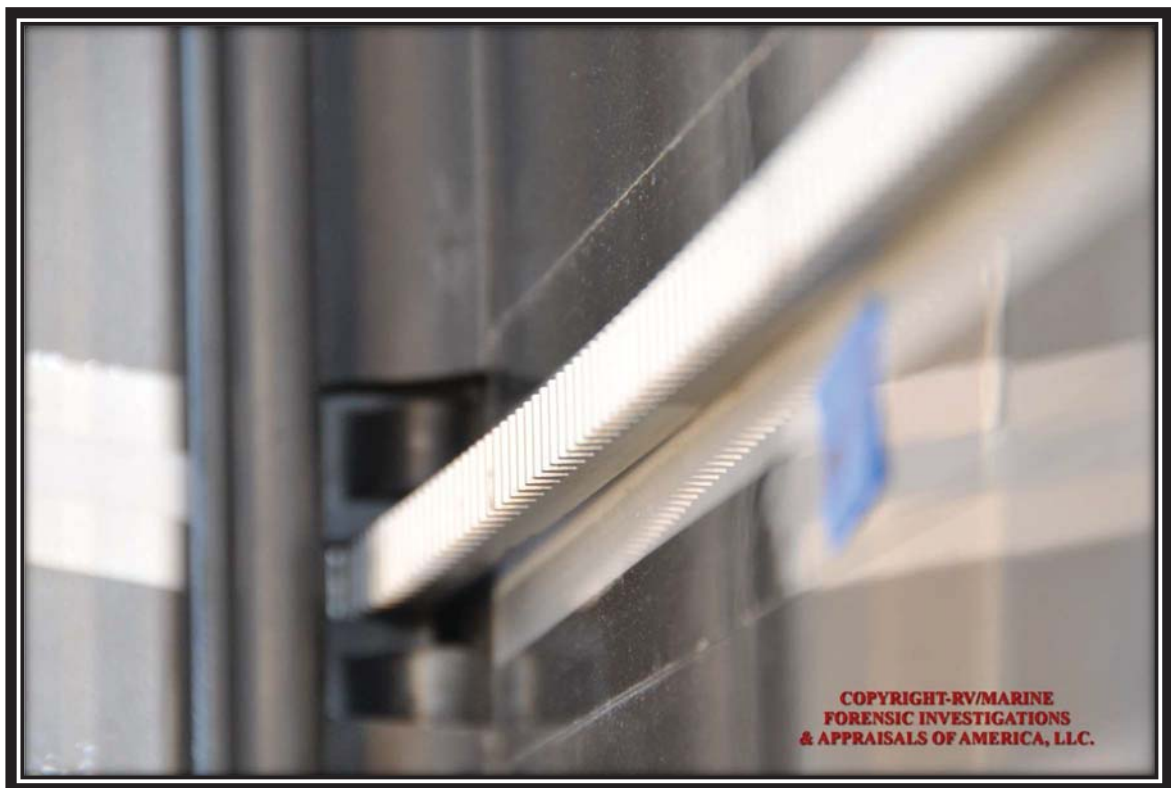
Fig. 20

20. *Slide out actuator bowed.* Conclusion: The actuator bowed when extended. Allegation Confirmed. As such it would not have been merchantable, i.e., it would not pass without objection in the trade. Refer to Fig. 20.

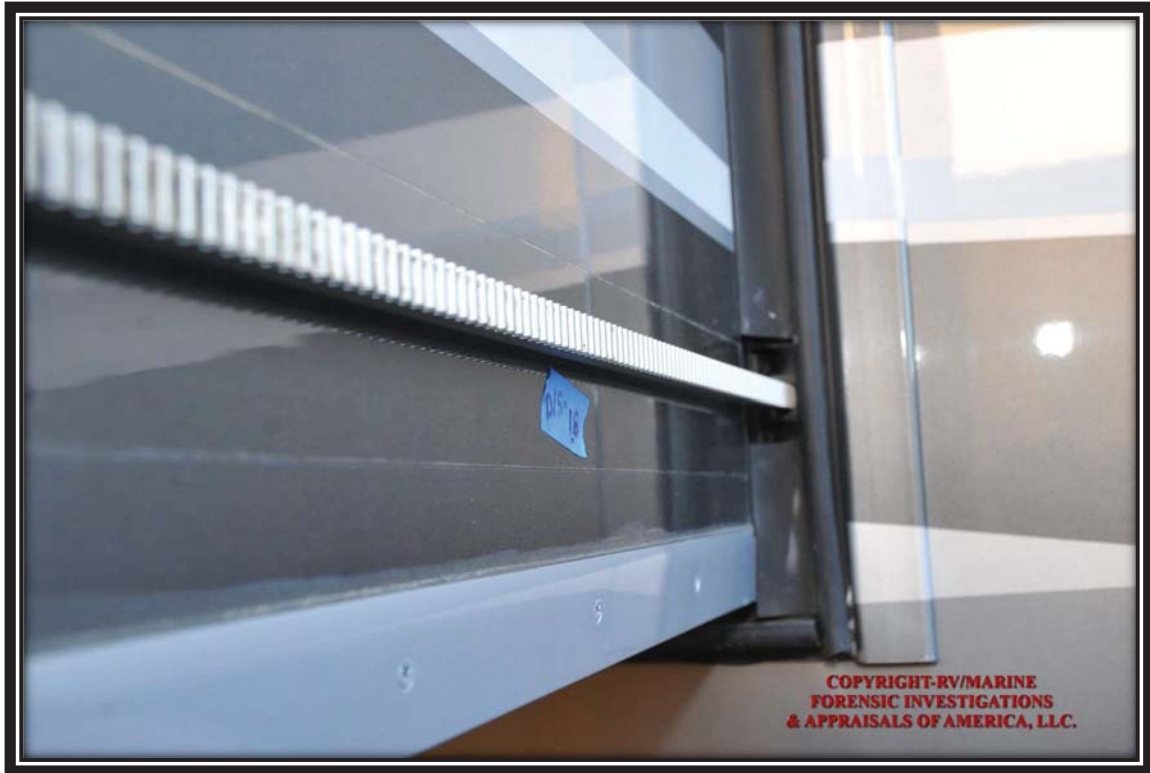
Fig. 21

21. *Slide out actuator bowed.* Conclusion: The actuator bowed when extended. Allegation Confirmed. As such it would not have been merchantable, i.e., it would not pass without objection in the trade. Refer to Fig. 21.

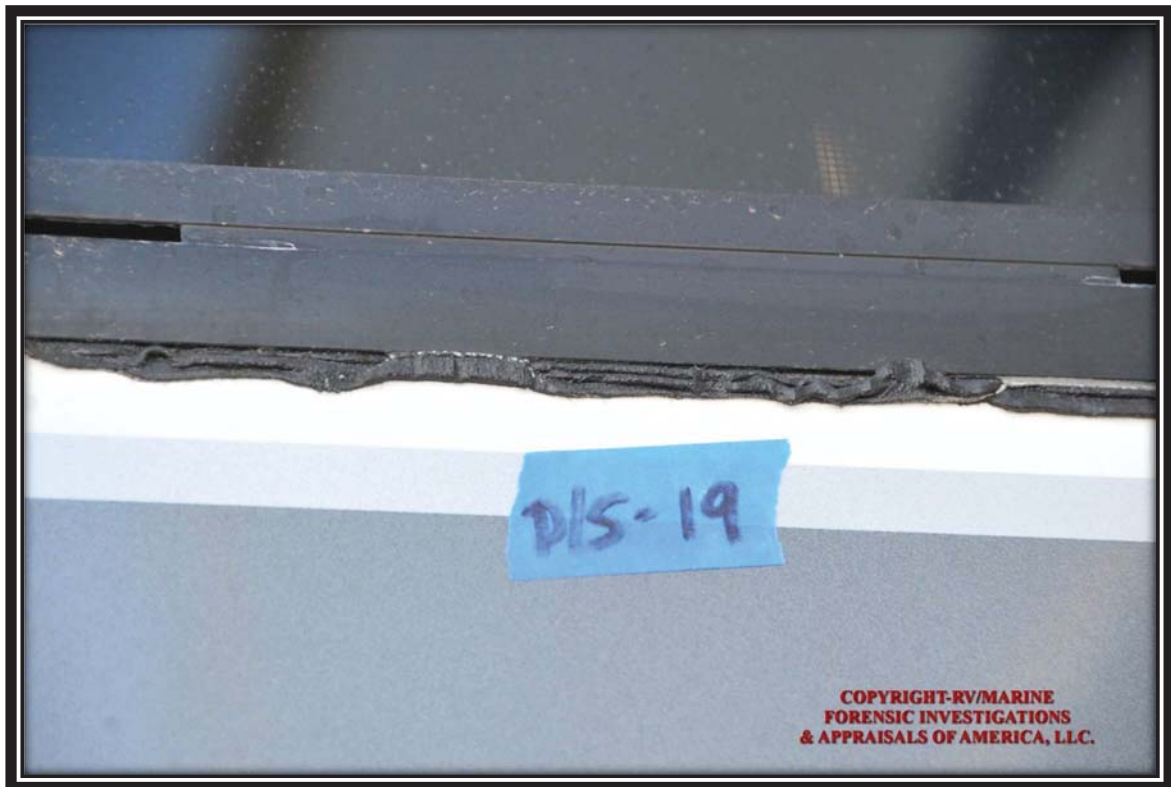
Fig. 22

22. *Excess caulking around window.* Conclusion: The window caulking was not trimmed off. Allegation Confirmed. As such it would not have been merchantable, i.e., it would not pass without objection in the trade. Refer to Fig. 22.

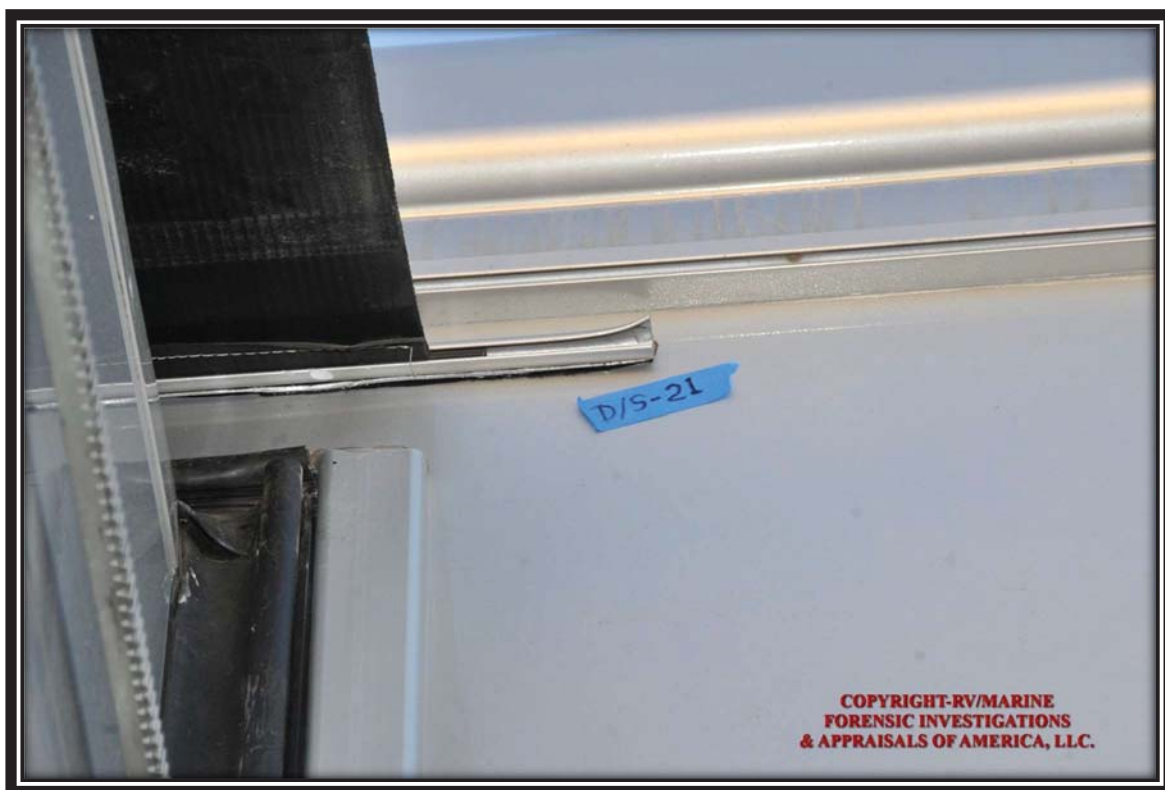
Fig. 24

24. *D/S awning rail not trimmed.* Conclusion: The awning rail had excessive length. Allegation Confirmed. As such it would not have been merchantable, i.e., it would not pass without objection in the trade. Refer to Fig. 24.

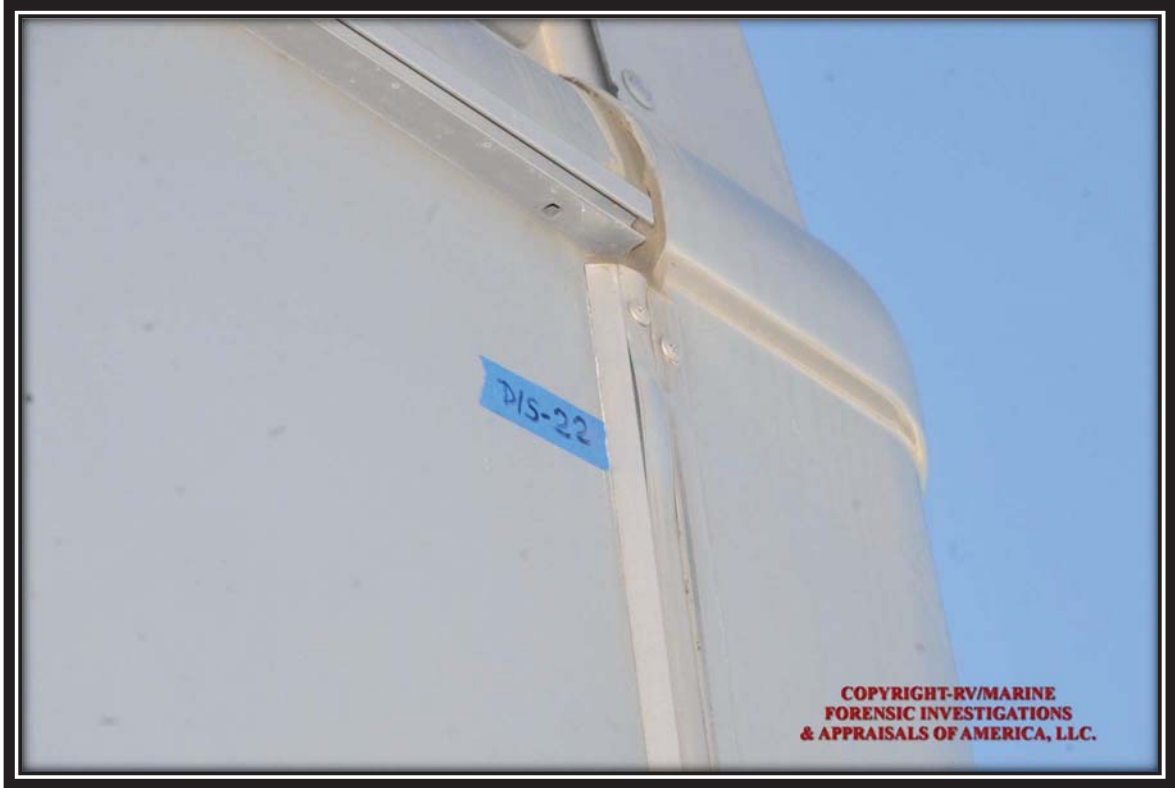
Fig. 25

25. *The trim insert is not flush.* Conclusion: The insert was not tight when installed. Allegation Confirmed. As such it would not have been merchantable, i.e., it would not pass without objection in the trade. Refer to Fig. 25.

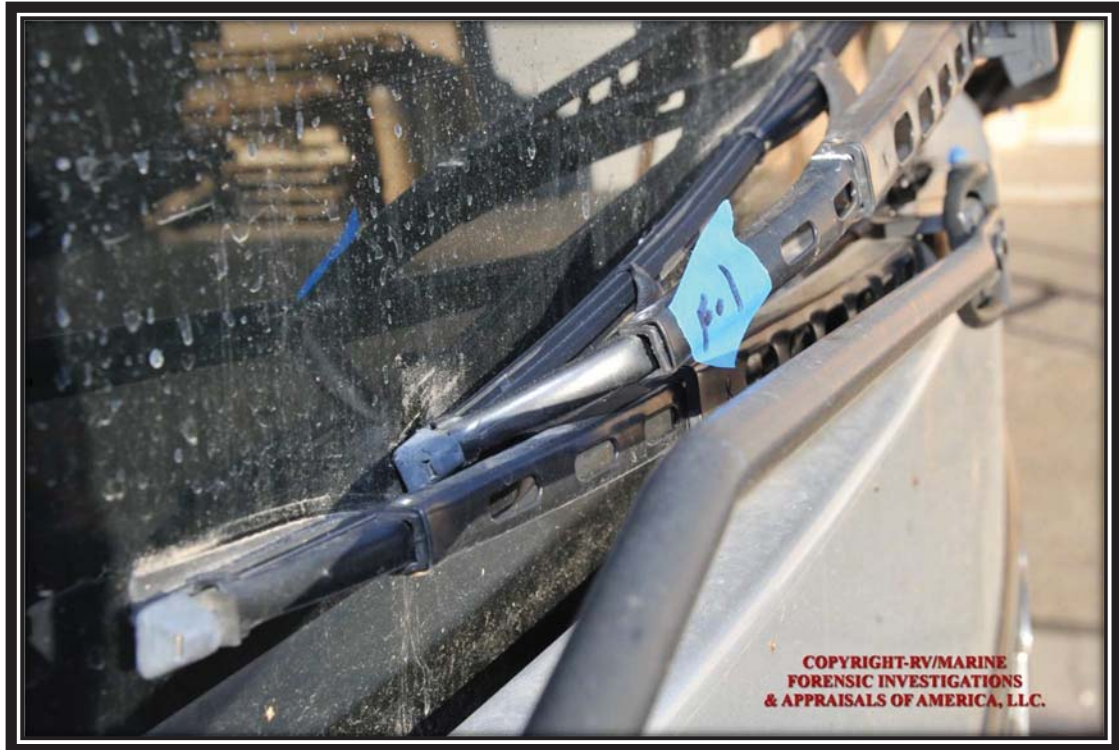
Fig. 26

26. *D/S wiper bent.* Conclusion: The wiper frame was bent at the end. Confirmed. As such it would not have been merchantable, i.e., it would not pass without objection in the trade. Refer to Fig. 26.

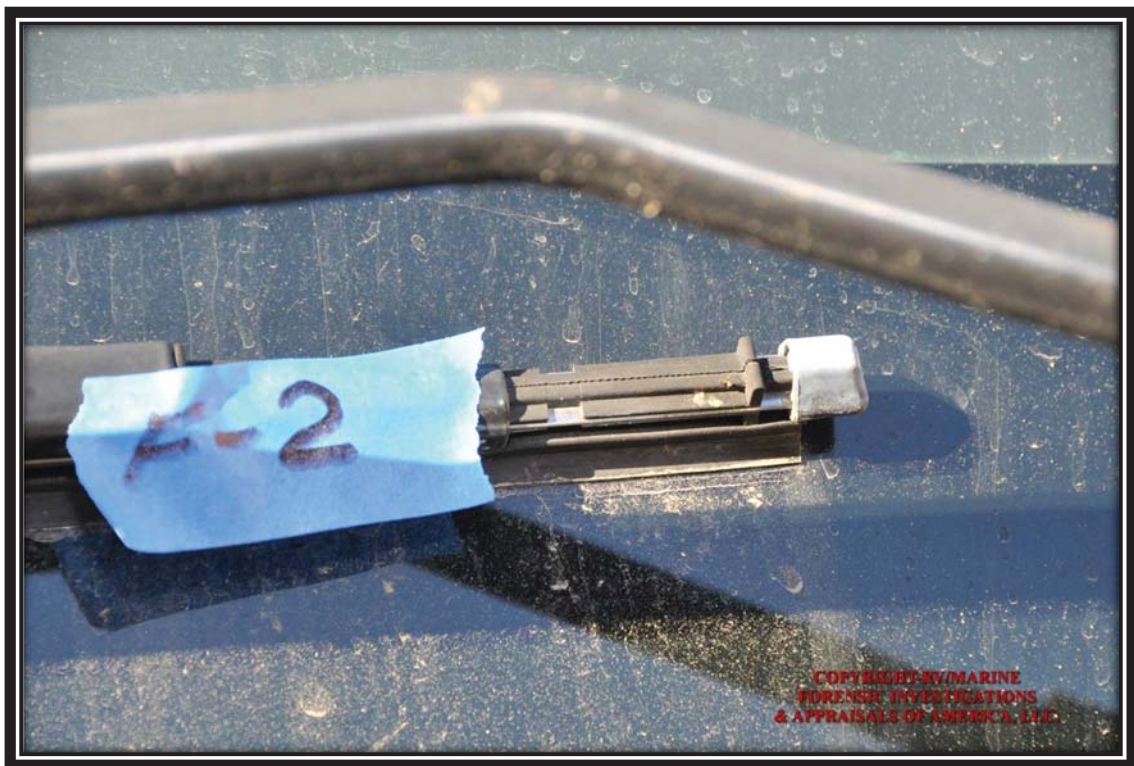
Fig. 27

27. *D/S wiper rubber was not secure.* Conclusion: The insert was pulled to one end. Allegation Confirmed. As such it would not have been merchantable, i.e., it would not pass without objection in the trade. Refer to Fig. 27.

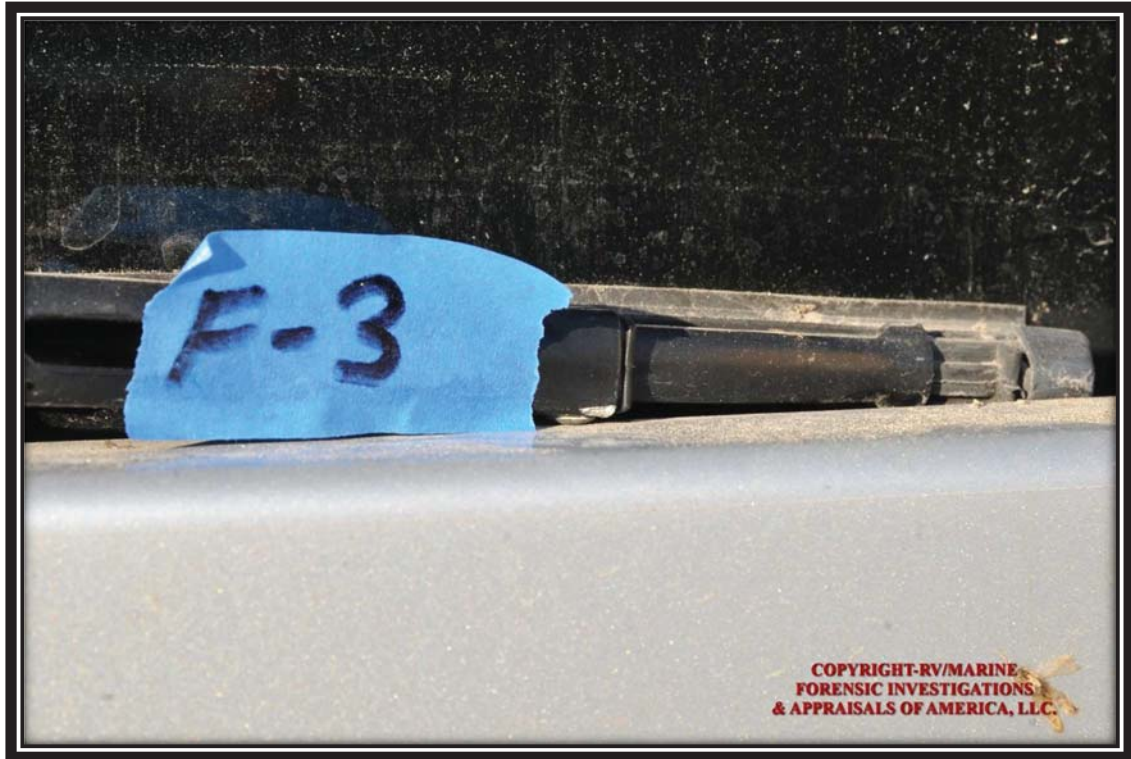
Fig. 28

28. *P/S wiper hitting fiberglass cap.* Conclusion: The wiper was making contact with the fiberglass cap. Allegation Confirmed. As such it would not have been merchantable, i.e., it would not pass without objection in the trade. Refer to Fig. 28.

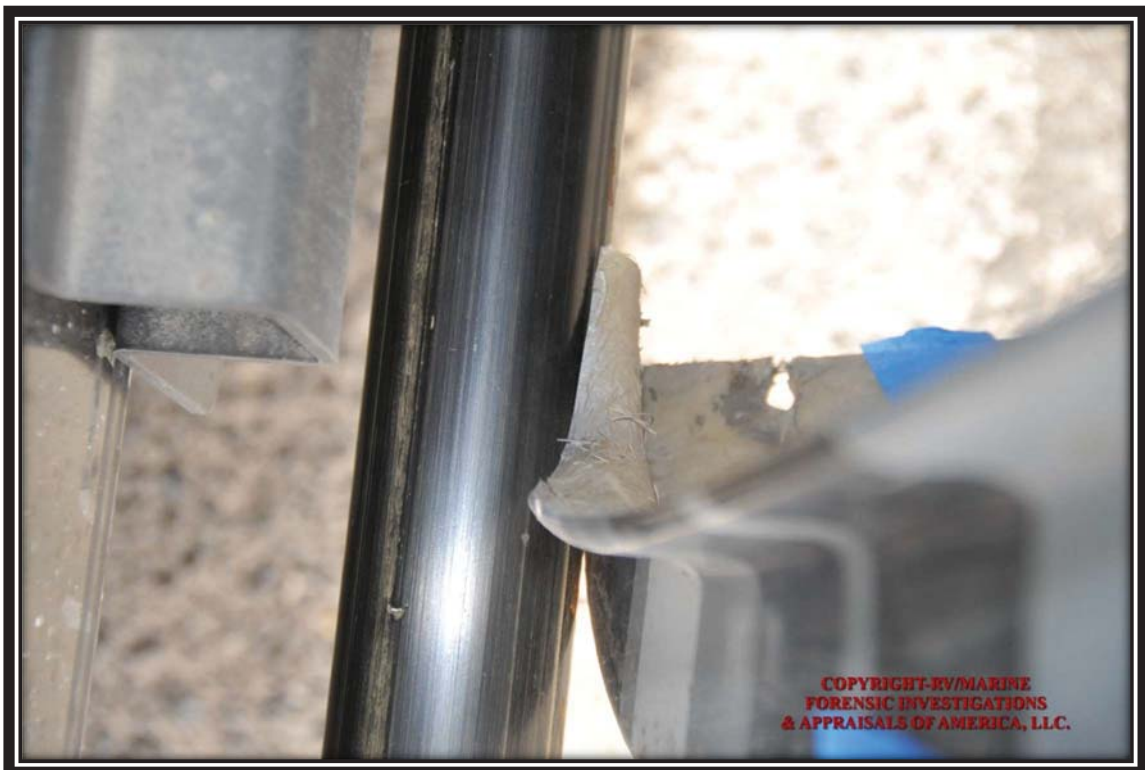
29. *Generator extension rubbing on cap.* Conclusion: When the generator is extended it rubs and shakes the front cap fiberglass. Allegation Confirmed. As such it would not have been merchantable, i.e., it would not pass without objection in the trade. Refer to Fig. 29 and videos C0017 & C0018.
